# Manhole Inspection Summary

# Manhole # S45C\_\_040MH

Insp Date: **8/21/08 8:39 AM**

**Location** Address: **Washington**

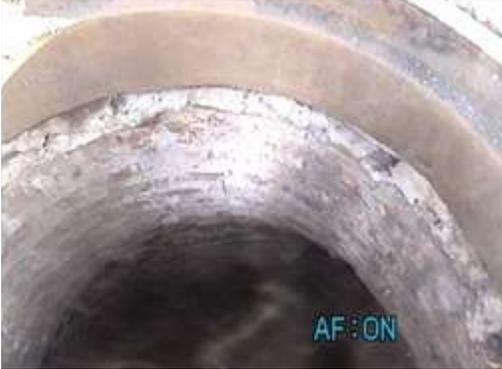
Defect 1

Condition:  Sound  Cracked  Root Intrusion  **Loose Brick**  Deteriorated

Loose brick

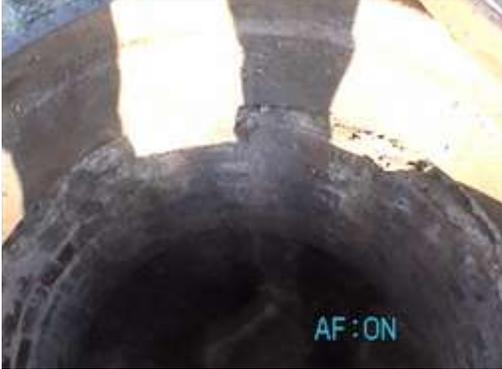
Defect 2

Infiltration:  None  Joint  Cracks  Mortar  Roots  **Wall**

Infiltration

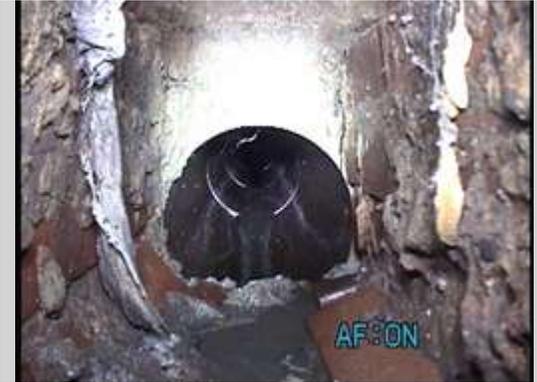
12 O'Clock Outflow

8 in. Circular Gravity Sewer  
Pipe Out @ 12 O'Clock

Pipe Height: **8.4** (in.) Rod and Bar (Angled)  
Pipe Material: **Clay**  Pipe Lined  
Invert Depth: **9.90** (ft.) Flow Characteristics: **Slow**  
Deposits:  None  Mud  Sludge  Debris  Grease  
Silt Depth: (in.) Deposits Extent:  
Infiltration: **None** Pipe Seal Cond: **Sound**

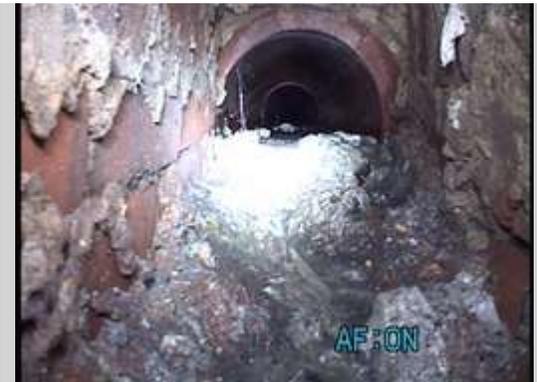
6 O'Clock Inflow

8 in. Circular Gravity Sewer  
Pipe In @ 6 O'Clock

Pipe Height: **8.4** (in.) Rod and Bar (Angled)  
Pipe Material: **Clay**  Pipe Lined  
Invert Depth: **9.65** (ft.) Flow Characteristics: **Slow**  
Deposits:  None  Mud  Sludge  Debris  Grease  
Silt Depth: (in.) Deposits Extent:  
Infiltration: **None** Pipe Seal Cond: **Sound**
